EXHIBIT 2

Ref: Vacant Sears Store Roof Inspection

Site Inspection Report

Site: Cross County Shopping Center
Location: Sears Lower Level

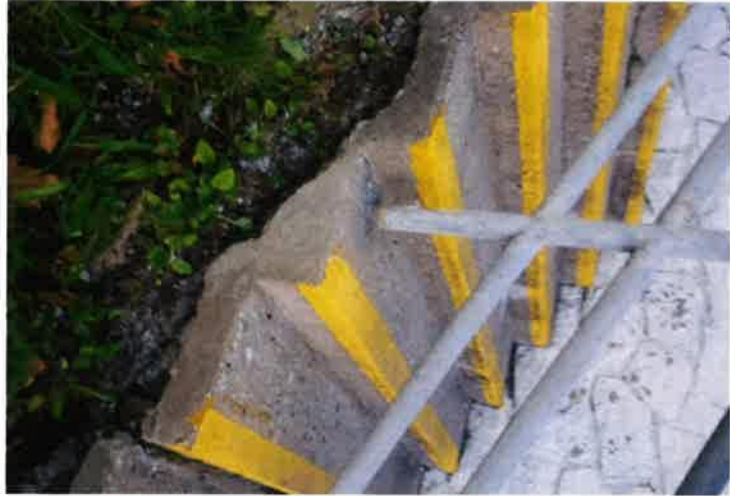
- 1. Missing
- 2. Damaged
- 3. Trip hazard
- 4. Curbside

- Inspector's Recommendations
- 1. Replace curb and sidewalk to comply with code
 - 2. Replace curb and sidewalk to comply with code
 - 3. Replace curb and sidewalk to comply with code
 - 4. Replace curb and sidewalk to comply with code

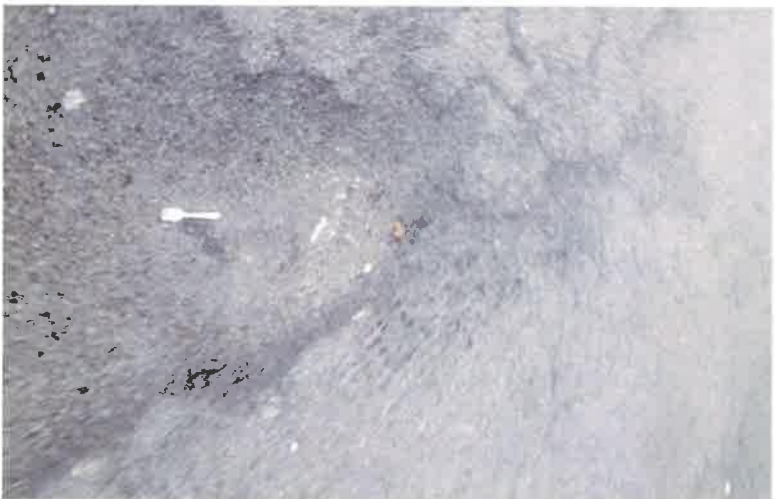
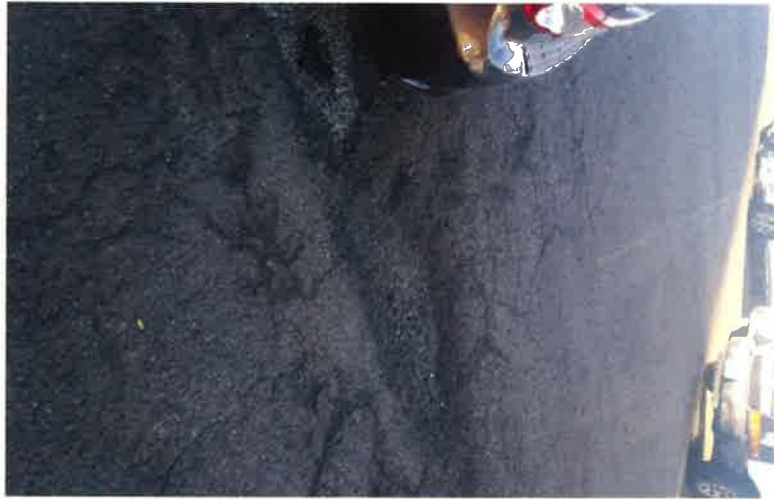
- 1 sunken pavement along compactor area
- 2 sunken pavement at trailer supports
- 3 pot holes causing a trip hazard

Hazards should be Addressed
